“TECH NOTES”

Use of Rock Cap Material As A Capillary Break

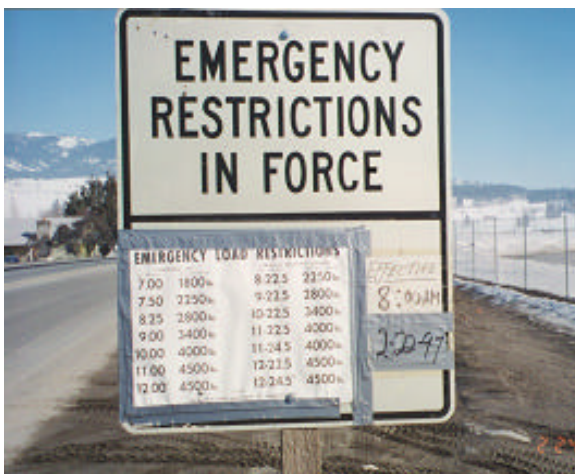
Photo 1. Load restrictions imposed on a WSDOT highway due to frost heave and thaw weakening.

On SR 20, from Colville to Tiger Junction, WSDOT recognized the need for an “all-season roadway,” that is, a roadway not subject to road restrictions or closures (Photo 1). Load restrictions on SR 20

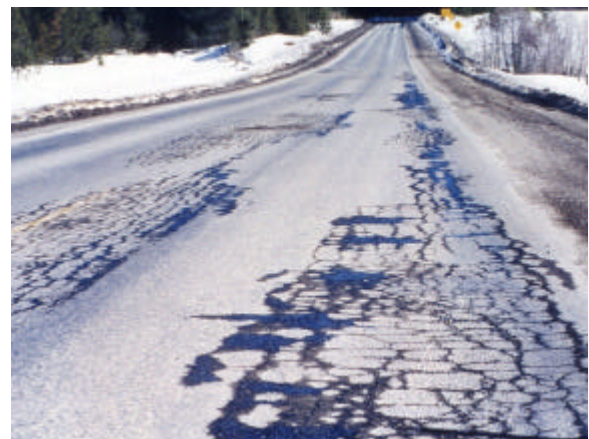
Photo 2. An example of the extent of damage caused by freezing and thawing on SR 20.

were yearly occurrences due to a weak pavement structure. As with many roads built in the 1930's and 40's, a minimal thickness of crushed stone base was placed on frost susceptible soils prior to a bituminous surface treatment (BST). Over time, the placement of additional layers of BST has resulted in a bituminous layer that is adequate for low volume roadways during dry seasons. However, this structure does not adequately support truck traffic during the spring thaw, consequently resulting in substantial fatigue cracking and rutting (Photo 2) due to the amount of thawed moisture in the base and subgrade.

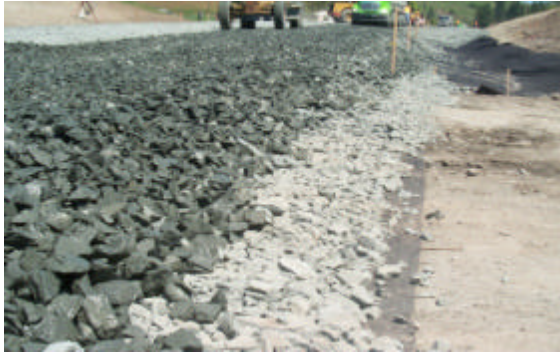
Photo 3. The open-graded nature of the rock cap aggregate provides a positive drainage blanket that allows excess water to be eliminated from the roadway.

To reduce the amount moisture allowed to enter the base layers, a capillary break using free draining rock cap material was constructed. Photo 3 shows the open graded nature of the rock cap aggregate and the positive drainage blanket provided.

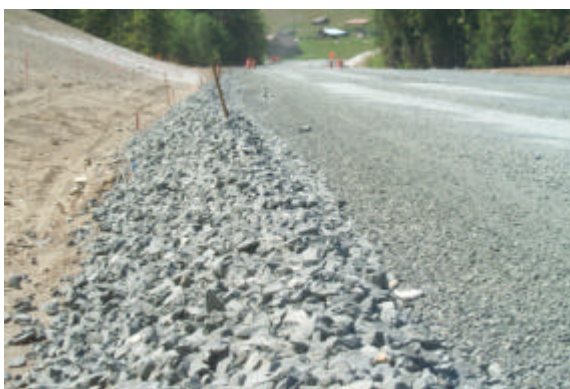
Photo 4. Crushed stone base placed on rock cap material.

WSDOT's design of the rock cap structure has been based on the practices used by the Idaho Department of Transportation (Idaho DOT). The structure used by WSDOT (Figure 1) consists of an 18-inch of aggregate (2 ½ to 3 inch maximum size) with 0 to 15 percent passing the ½ inch sieve. Above the rock cap layer, 4 inches of crushed stone base was placed and compacted (Photo 4), followed by an 4 to 5 inch asphalt wearing surface.

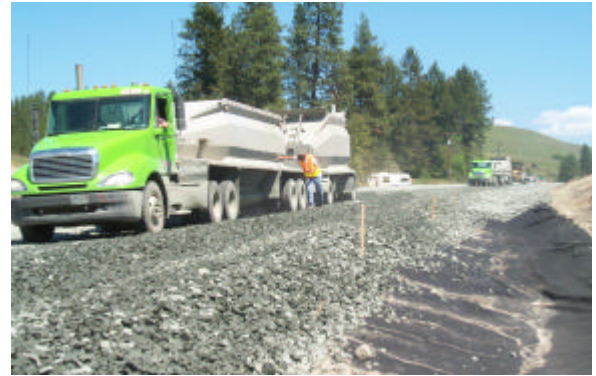
Photo 5. Placement of rock cap material on SR 20. (Note the use of the geotextile fabric.)

Construction of the rock cap roadway consisted of placing the rock cap aggregate directly onto the existing BST roadway. However, where placement occurred in areas of natural subgrade or embankment widening, a geotextile fabric is placed as a separator to prevent the intrusion of fine particles into the rock cap layer (Photo 5).

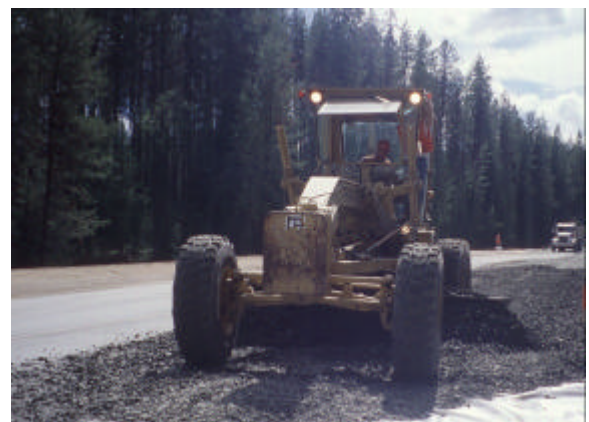
Photo 6. Grading the rock cap material.

The construction sequence for the rock cap structure consists of the placement of the rock cap aggregate in 6 inch maximum lifts, followed by grading (Photo 6), and compaction (Photo 7). Typically, a 300 to 500 foot long section is completed to full depth before the entire operation progresses along the roadway.

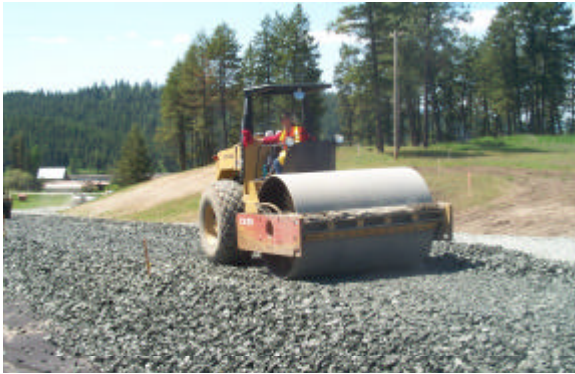
Photo 7. Compaction of the rock cap material.

The rock cap is compacted by using a 10-ton vibratory roller. The use of water during compaction (Photo 8) is essential to reduce the inter-particle friction when compaction energy is applied.

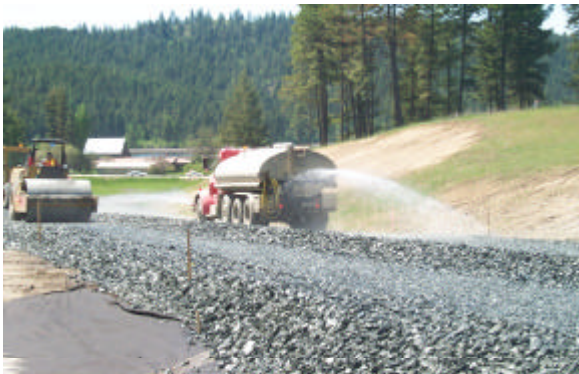
Photo 8. Watering and compacting rock cap aggregate.

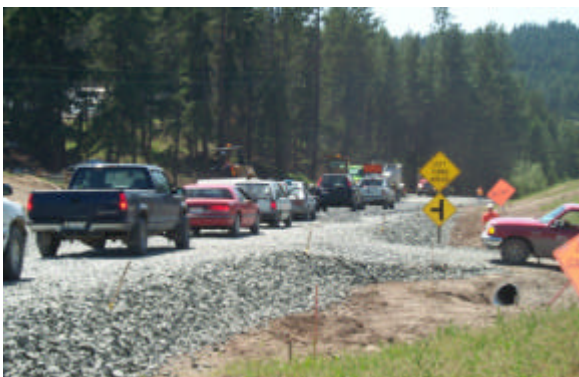
Photo 9. Vehicle traffic driving on the compacted rock cap surface.

Idaho DOT had previously described rock cap material, while under traffic, as acting like an arrestor bed on a truck escape ramp. Nevertheless, the projects constructed on SR 20 from 1998 to 2002 (Photo 9) exceeded all expectations, and the stability of the roadway for automobiles and construction vehicles was excellent.

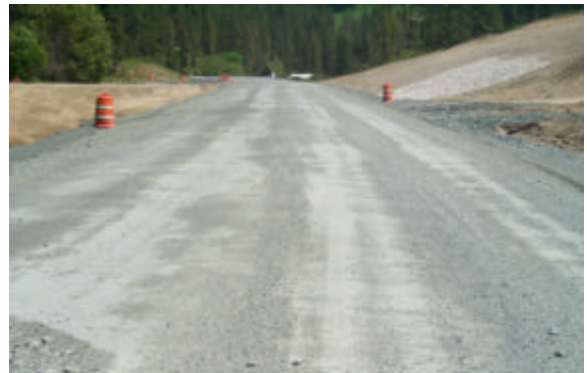
Photo 10. The layer of crushed stone base tightened the rock cap surface by filling voids thus providing a temporary driving surface.

Following the placement of the rock cap layer, a 2-inch layer of crushed stone aggregate was placed on the roadway (Photo 10). The layer of crushed stone base tightened the rock cap surface by filling voids thus providing a temporary driving surface until the final thickness of crushed base material (4 inches) and asphalt surfacing (4.5 inches) can be placed.

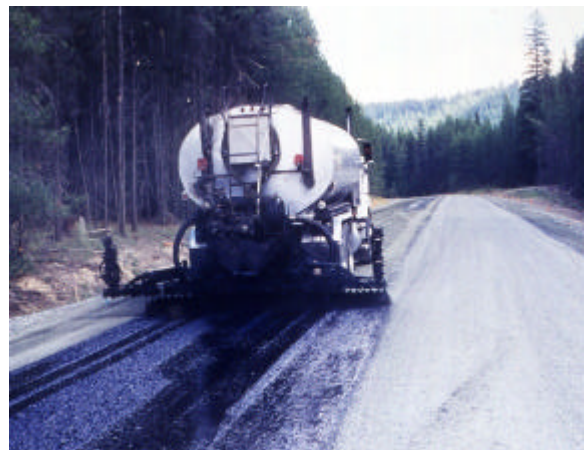
Photo 11. Placement of CMS-2P emulsion prior to the application of BST aggregate.

Following the construction of a section of the rock cap and crushed stone base layers, WSDOT then applied a BST surface (Photos 11 and 12) to eliminate maintenance concerns. The BST maintained the roadway cross slope and profile while providing a driving surface acceptable to the public until the final ACP wearing surface was placed (Photos 13 and 14).

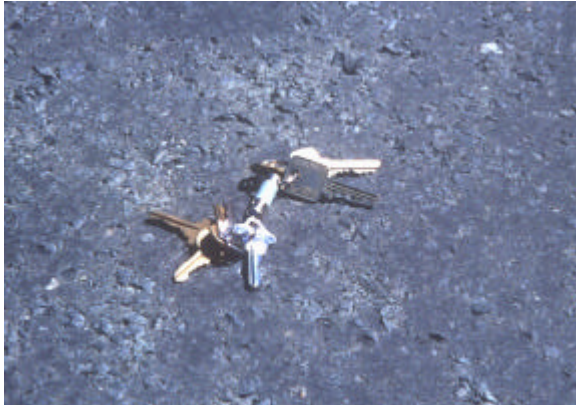
Photo 12. The application of the BST provides a wearing surface acceptable to the public prior to placement of the asphalt overlay.

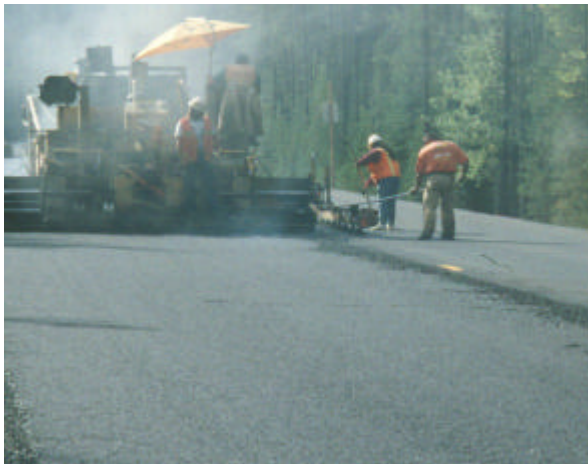
Photo 13. Crews place the final asphalt overlay on SR 20.

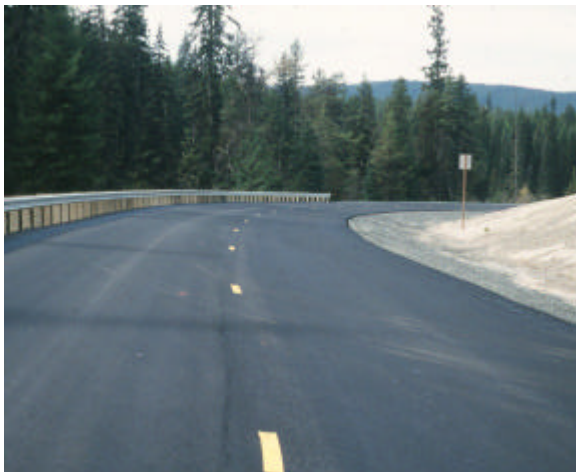
Photo 14. The final asphalt overlay on the section of SR 20 with the rock cap material in place.
